February, 2000

Series 150 Bellows and Guide-plate Improvement

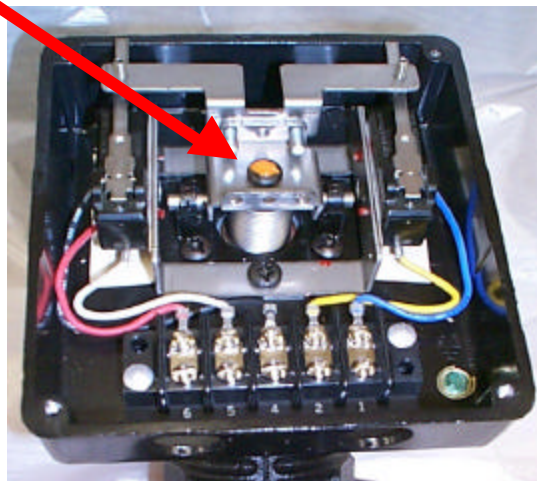
In March of 1999, McDonnell & Miller posted a service bulletin on the FSH representative web site titled "Series 150S Product Update". It explained the various changes made to the Series 150 product line to correct field problems. One of the issues discussed was "Float Rod Rubbing" which is a condition where the float rod rubs against the guide plate within the head assembly. The condition is pressure related and more predominated at pressures above 50 psi. However, it can also occur at lower pressures. Symptoms are sluggish operation of both burner and pump control. Instances of float rod rubbing although rare warranted correction. The following graphics below explain two changes McDonnell & Miller made as corrective action to all models of the Series 150.

First, to enhance bellows stability, we mechanically secured the bellows assembly directly to the bearing assembly. This improvement was implemented on all Series 150/157 and 150S/157S products in June 1999. (See graphic below).

This change prevents the bellows from deflecting due to increased operating pressure thus maintaining float rod centering in the guide-plate.
